Background

Solution

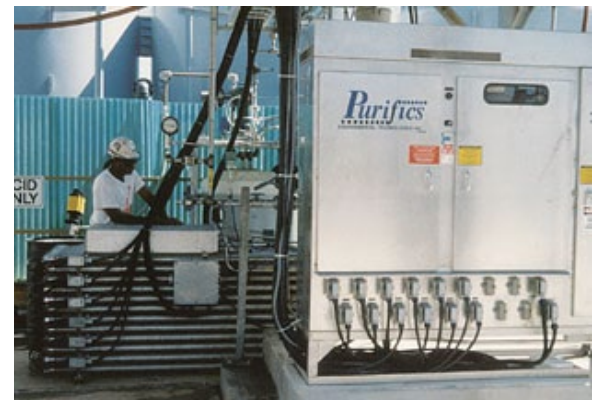
- **Photo-Cat** system; CERCLA ID #TXD
- No flocculation or pretreatment
- Corrosion resistant construction
- Surface water discharge
- Duty 24/7, >35,000 hours
- Operated from 1994-2000 for a full site cleanup
- Complexity and footprint reductions
